ACID CLEANING BRICKWORK

TECHNICAL BULLETIN CTB-15

Rev 3, November 2003

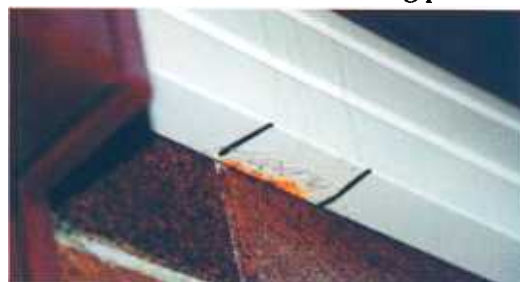
Acid leaching of pigment directly from paint coatings subjected to acid splash, will result in unsightly "bleached" stained areas which will further deteriorate and lead to corrosion.

Acid cleaning of brickwork associated with two storey construction may pick up lead from lead flashings and re-deposit with sand from the mortar, within the roof gutters. Corrosion of the guttering rapidly follows.

Figure 1: Example of corrosion caused by incorrect acid brick cleaning practices.

BlueScope Steel Limited recommend that wherever possible acid cleaning should not be conducted subsequent to erection of metallic coated items. However, when this is not possible it is recommended that the areas be appropriately masked during the acid cleaning operation. Where the possibility of inundating the metallic item appears to be present, the item should be thoroughly wetted prior to the application of the acid to the adjacent brickwork. Immediately after acid application, the item should be thoroughly washed with water a number of times, working from the top of the brickwork to allow complete removal of the spent acid products.
