CORROSION

FERTILIZER MANUFACTURING AND STORAGE BUILDINGS

TECHNICAL BULLETIN CTB-24

Rev 3, November 2003

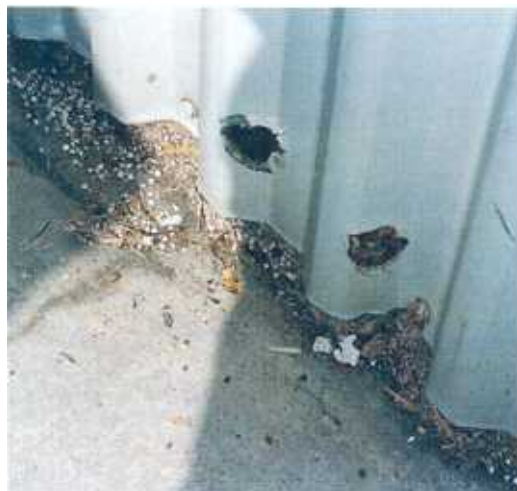
Figure 1: Example of corrosion resulting from contact with fertilizer.

The broad spectrum of fertilizer products manufactured to meet the demands of the agriculture industry may expose the cladding material to a variety of fertilizer products during the service life of the building. Therefore, COLORBOND® Stainless prepainted steel is the only product recommended by BlueScope Steel Limited for roof and wall sheeting on fertilizer manufacturing and storage buildings.

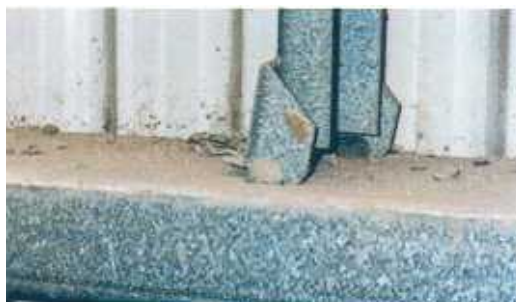
Figure 2: Build-up on purlin

As purlins are exposed to the same environment, BlueScope Steel recommend they be manufactured from GALVSPAN® Z450 steel and incorporate a turned-down lip to prevent the build-up of fertilizer dust. Furthermore, the purlins must be postpainted with an appropriate high-build industrial paint system as

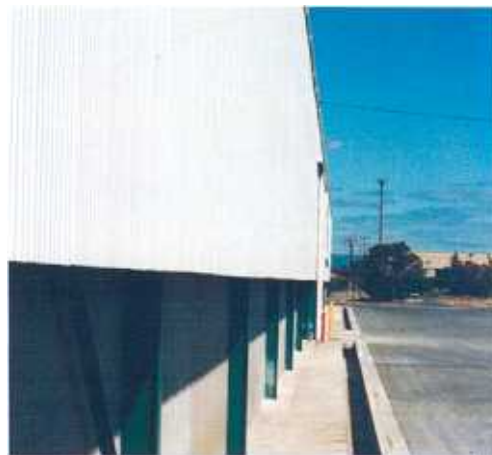
Figure 3: Example of a dwarf wall

Experience has shown that the incorporation of a masonry dwarf wall can dramatically reduce the instance of mechanical damage and corrosion to wall cladding. This avoids direct contact between the fertilizer and the cladding.
