# European exposure tests of pre-painted steel panels

10-year Eurodes programme confirms the  
outstanding comparative performance of substrate  
in 55% Al-Zn metallic coated steel

# 55% Al-Zn<sup>SM</sup>

### FOR PRE-PAINTED SUBSTRATE

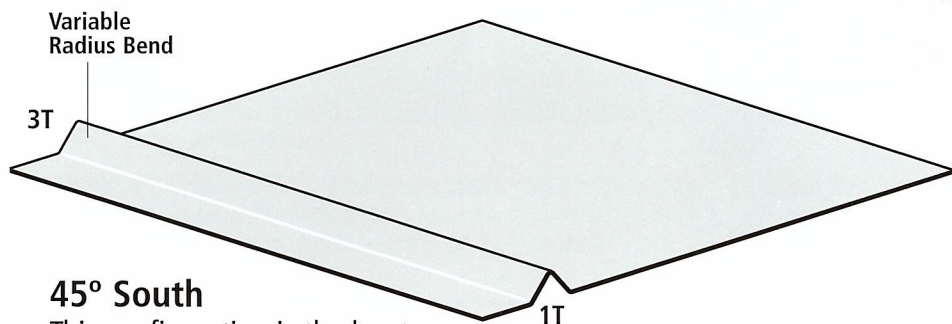
## 45° South

This configuration is the least severe, and is traditionally used to determine chalk and fade resistance of the paint system.

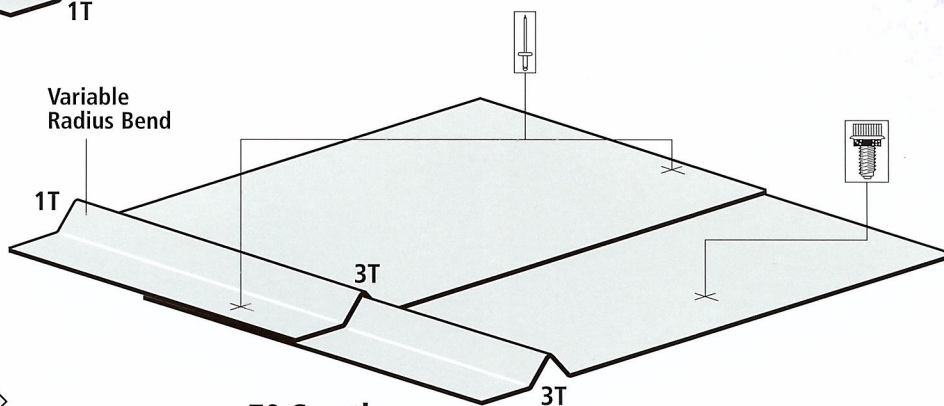
## 5° South

The severest configuration, representing roof areas.

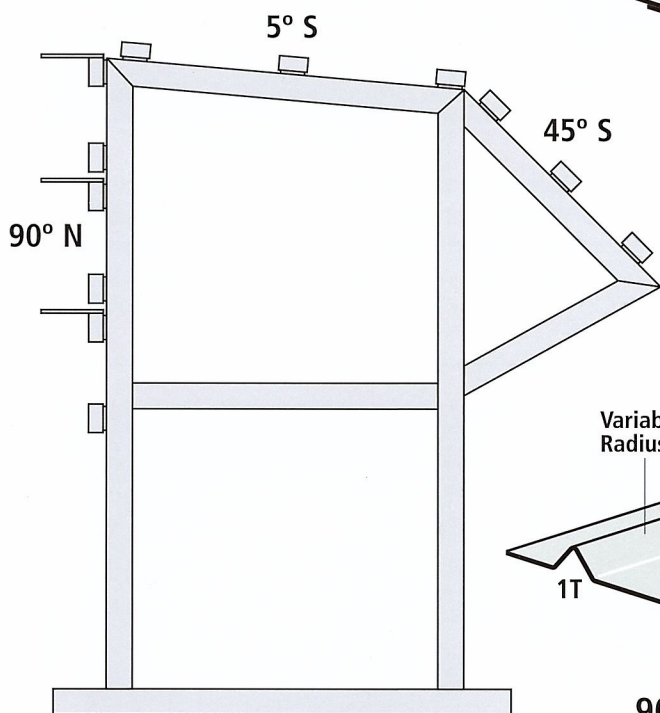
The exposure rack design.

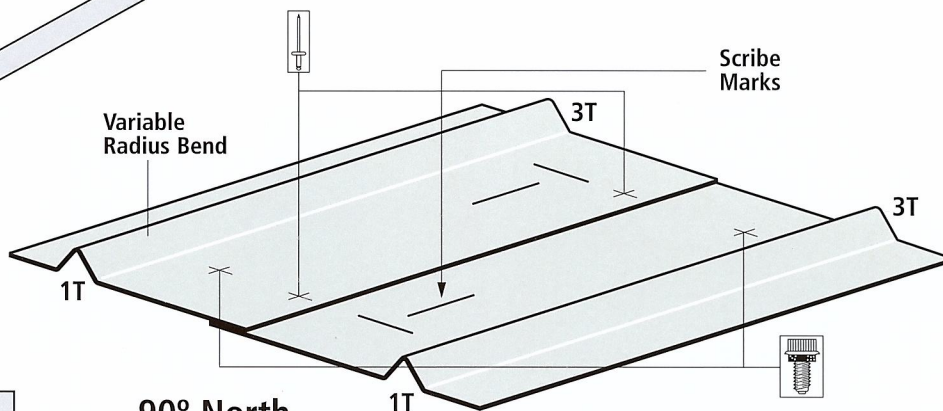
## 90° North

This represents the side wall of a building; the north-facing aspect gives the harshest side wall exposure, with long times of wetness. The top part of each panel is shaded with an overhang to replicate sheltered area conditions.

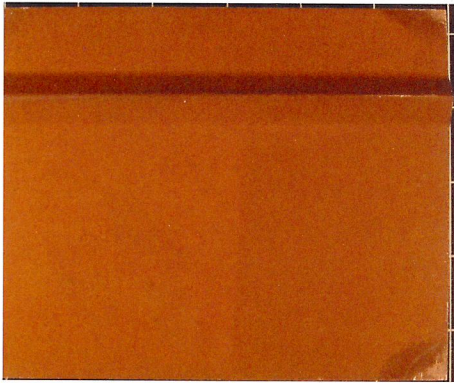
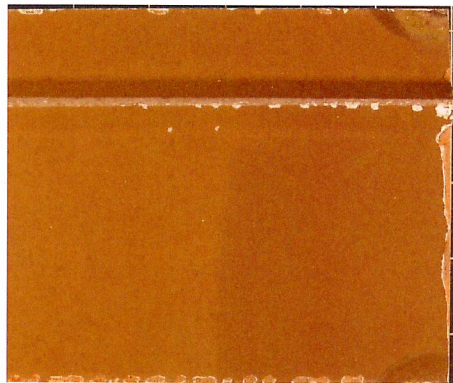
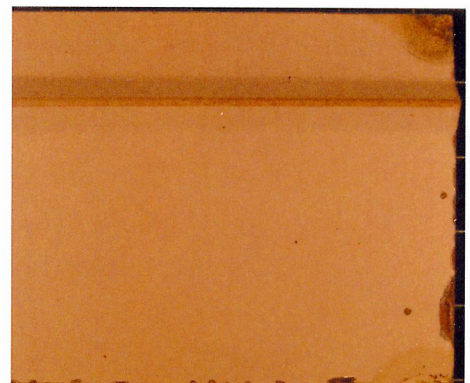
**45° South: polyester coatings.** The Galfan (Zn-5% Al) and hot-dip galvanised panels show paint loss along the edges, white corrosion along the bend, and blistering. The 55% Al-Zn panel remains in excellent condition.

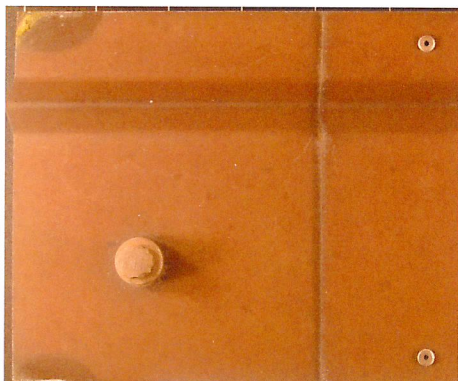
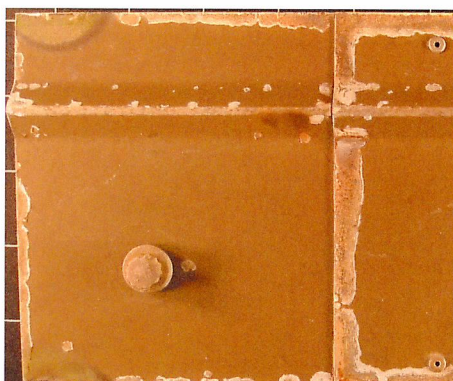
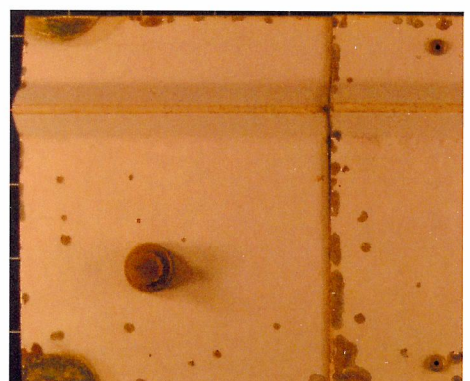
**5° South: polyester coatings.** Realistically replicating a building roof in this severe marine environment, these panels with 10 years' exposure clearly show the excellent performance of 55% Al-Zn. The 55% Al-Zn panel has no detectable edge creep rusting or blisters and just a little staining on bends and edges. In stark contrast, the Galfan and hot-dip galvanised panels

show edge creep that exhibits the total dissolution of the underlying substrate's metallic coating, with paint loss and rust on the bends and flat surfaces. There is severe corrosion along the bend, and severe blistering in flat and formed areas and around fasteners is also obvious.

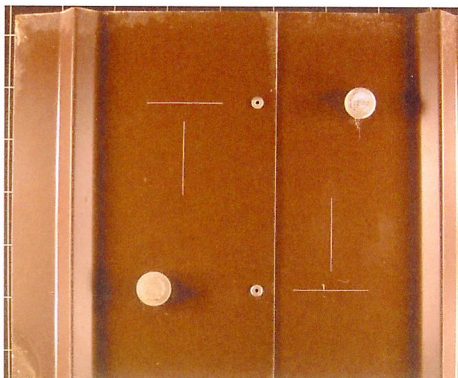
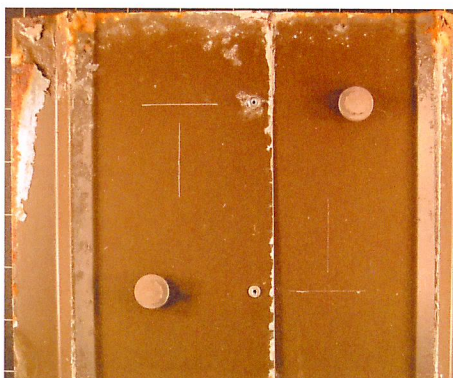
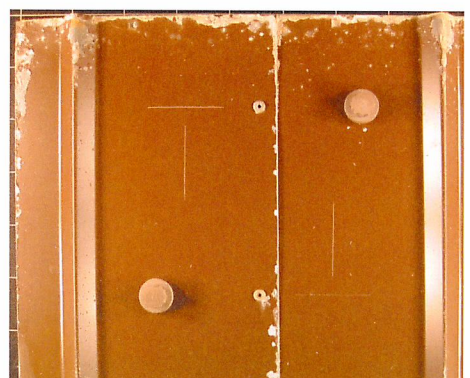
**90° North: polyester coatings.** This area replicates side walls with the longest time of wetness, with an overhang providing a sheltered area. The 55% Al-Zn panel shows virtually no failure, proving the product's

excellent sheltered area corrosion resistance. Both the other panels (the hot-dip galvanised shown here is coated with silicon modified polyester) show extensive substrate corrosion and paint loss on edges, bends and flat areas

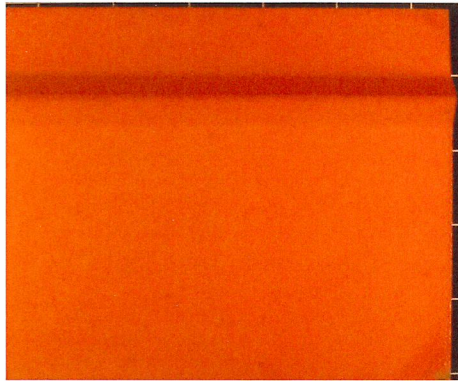
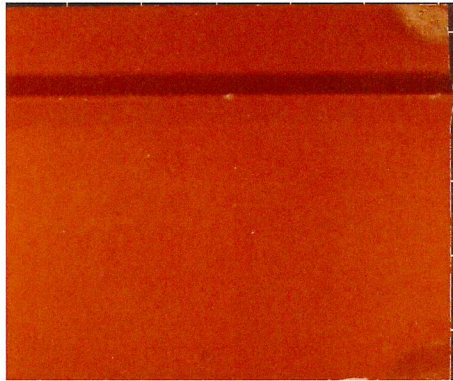
**45° South: PvdF coatings.** Both these panels, coated with the fluorocarbon paint system, show good performance, although some paint loss is seen along the edges of the Galfan panel, and a few blisters are visible on the bend.

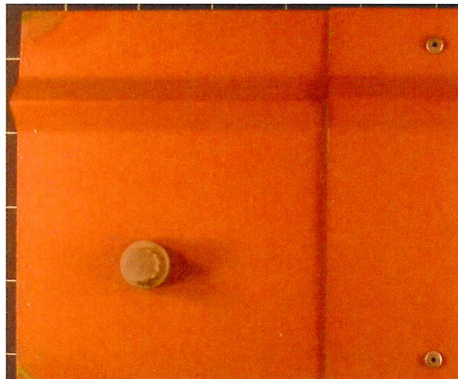
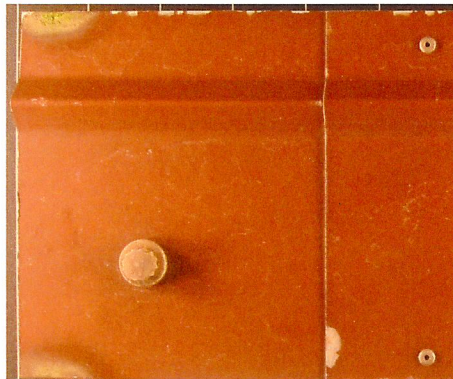
**5° South: PvdF coatings.** This more aggressive orientation causes problems for the Galfan panel, with loss of paint adhesion along the sheared edges, and blistering on the bend and flat areas. The 55% Al-Zn panel remains free of any significant failure: there are fine blisters along the edge, but they have not developed and the paint still adheres to the substrate.

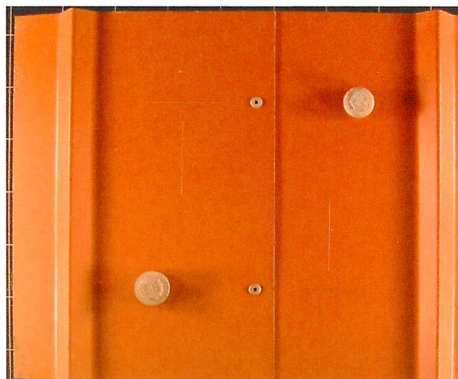
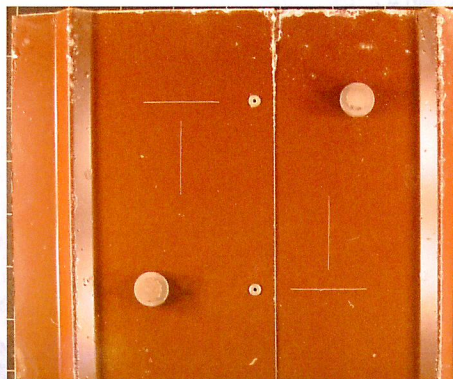
**90° North: PvdF coatings.** The strong sheltered area corrosion resistance of 55% Al-Zn is again clearly shown, demonstrating its all-round

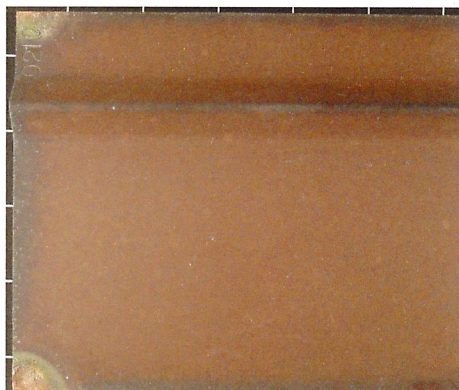
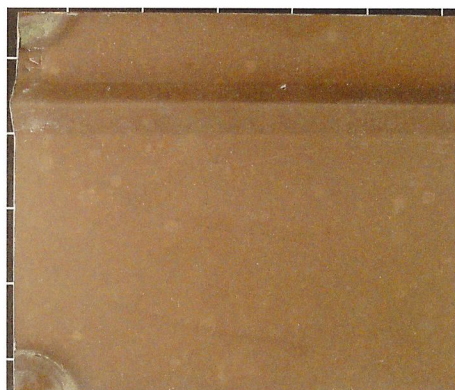
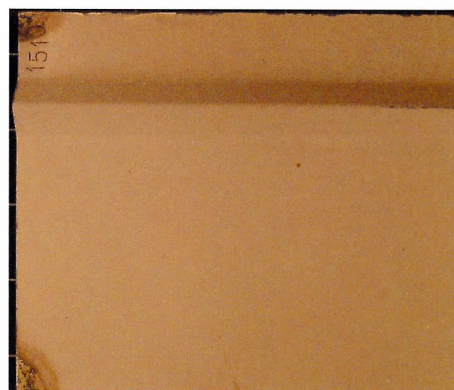
**45° South: polyester coatings.** After 10 years, the 55% Al-Zn and hot-dip galvanised panels show virtually no failure. The Galfan (Zn-5% Al) panel has suffered paint loss on the bend and the edges.

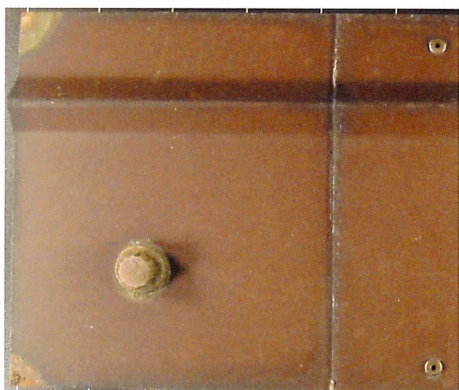
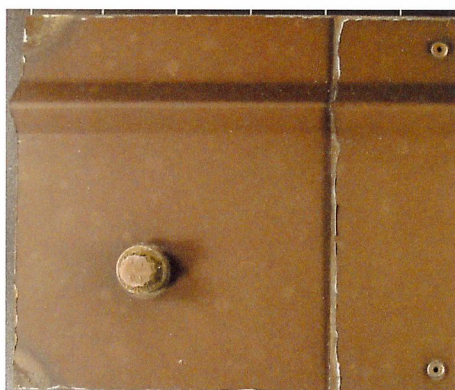
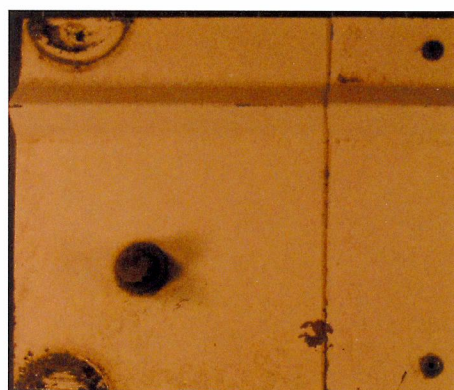
**5° South: polyester coatings.** This configuration provides a very severe test. None of the panels, however, display appreciable corrosion; but the Galfan and hot-dip galvanised specimens show paint loss along the edges.

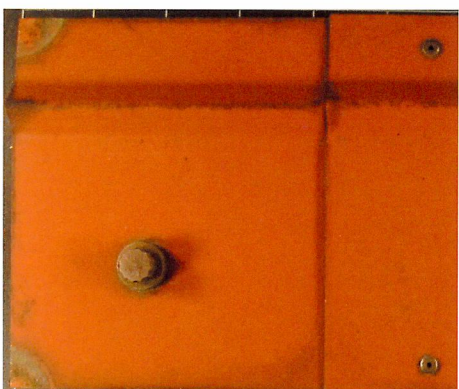
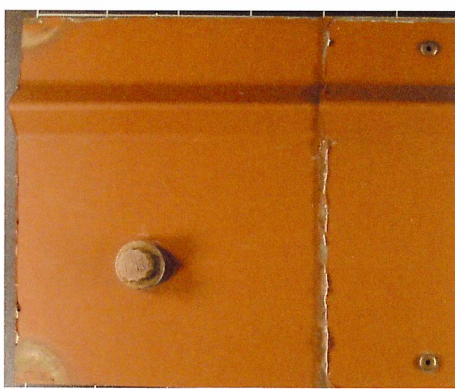
**5° South: PvdF coatings.** The hot-dip galvanised panel shows appreciable paint delamination on the overlap and at the sheared edges. The 55% Al-Zn panel is in good condition, except for some staining on the bend.

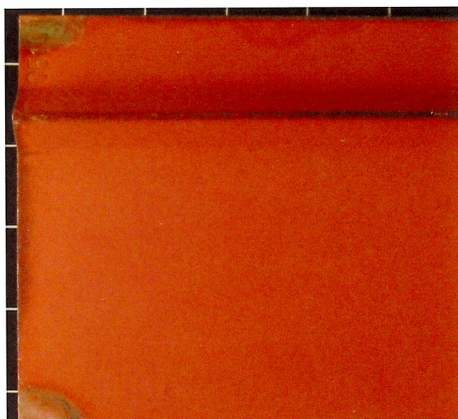
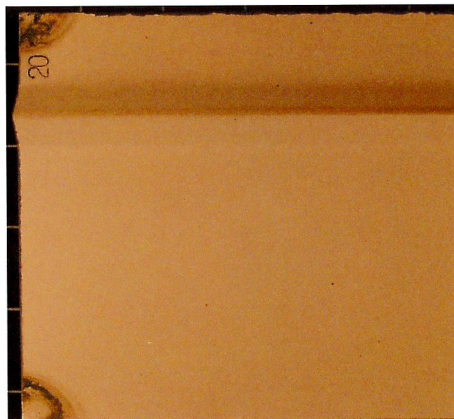
45° South: silicon modified polyester (SMP) coatings.

The SMP topcoat is brittle (less formable) than polyester, and is expected to exhibit more micro-fracturing on bends. This effect is well documented above. Whilst the 55% Al-Zn panels show staining on the variable radius bend for all three exposure orientations, no substrate corrosion (red rust) can be observed. The galvanised panels all show varying degrees of red rust on the V-bend, on

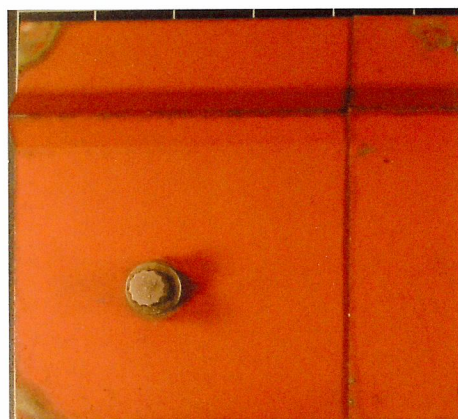
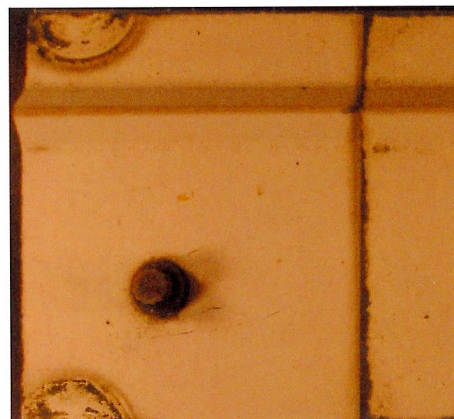
5° South: SMP coatings.

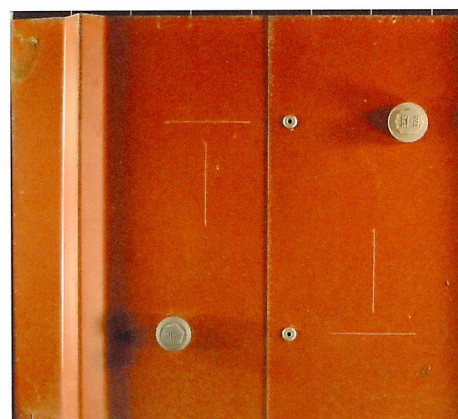
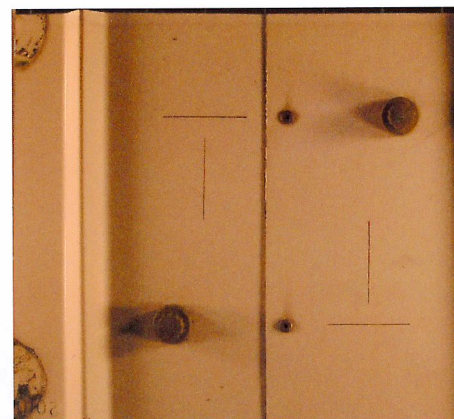
90° North: SMP coatings.
